Drainage Plow Tubing Installation: Field Evaluation of Pull-Behind Plows¹

Summary

Features of Pull-Behind Drainage Plows at the 2000 Lorain County Field Day

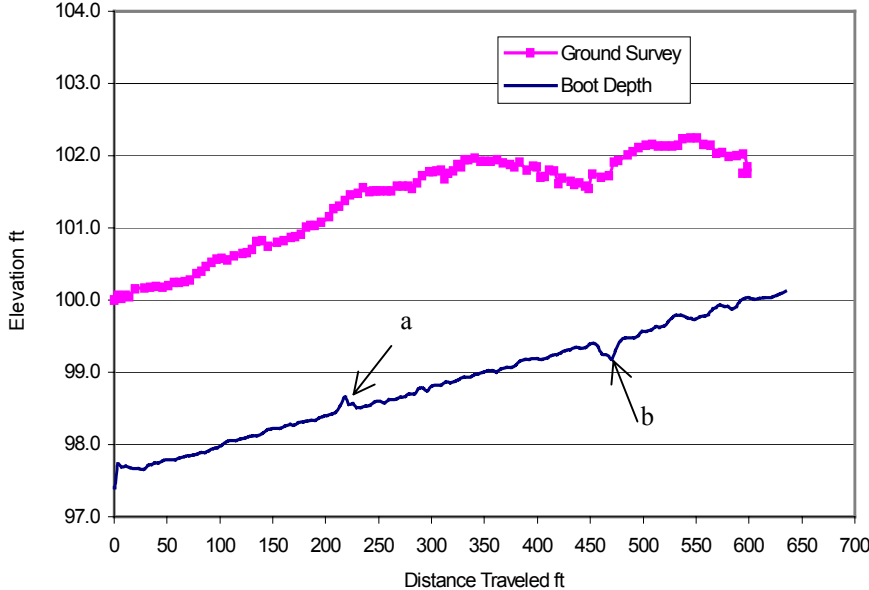
Figure 1. Pre-ripping too deep.

Figure 1. The operator of this plow started pre-ripping from the end of the string and worked back towards the outlet. With no survey shots and no laser guidance, this operator proceeded back with little or no information about the grade or depth, just information from the previous run. At “b” during the pre-rip, the plow followed the ground surface change making the plow pre-rip too deep. Catching this mistake, the operator quickly raised the plow above the final installation depth. The boot depth graph taken during installation shows a reverse grade of 0.30’, which occurred when the plow passed through this deep pre-rip area. This mistake is due to operator error, one of the numerous problems observed with inexperienced operators. This plow required some manual control and in figure 1 “a” the operator wasn’t paying enough attention allowing the plow to come up 0.12’ then adjusting down 0.17’ producing a negative grade. In all, five negative grades can be seen in figure 1.

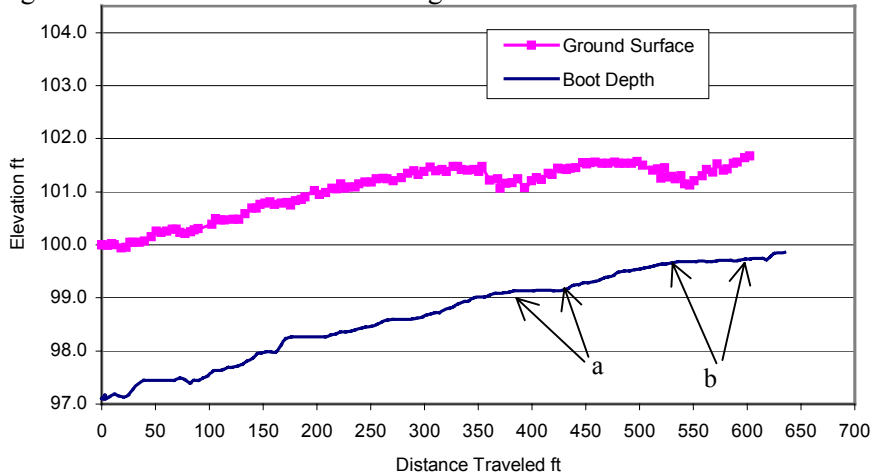
Figure 2. Incorrect transmitter setting.

Figure 2 shows no apparent grade control because the operator did not set the correct grade into the transmitter. This plow operator used the grade chain and manual adjustment to keep the pipe depth close to the design depth. The boot depth graph does appear to show a negative grade but is out of the detection limit of the equipment. At letter “a” the boot depth stayed level for approximately 60 feet. At letter “b” the boot depth stayed level for approximately 90 feet. Improved installation could have occurred if this operator did not do the work hastily.

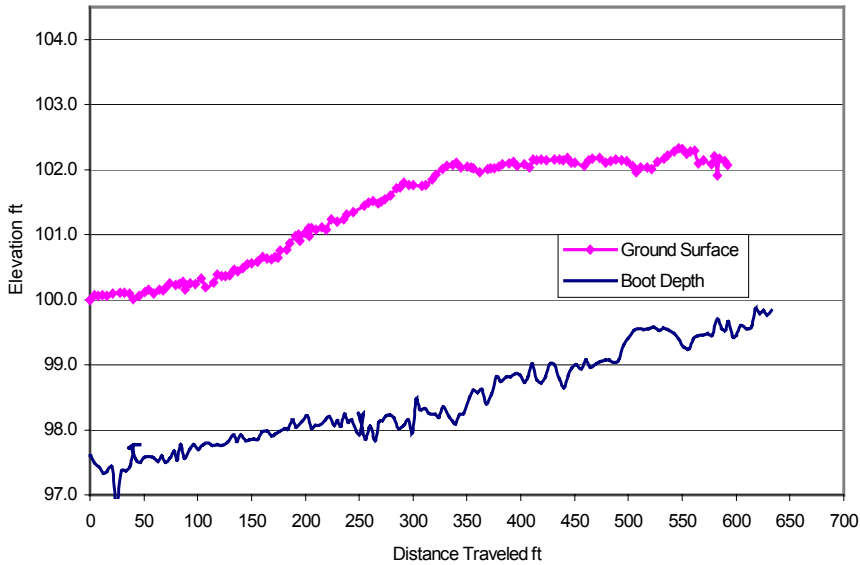
Figure 3. Untrained operator.

Figure 3. This graph shows numerous problems that indicate operator training and machine setup were inadequate. The pitch of the plow shank was incorrectly adjusted on this plow. The automatic grade control was unable to overcome the improper setup and the plow repeatedly produced negative grade at boot depth. The ground surface conditions and the design for this run were not difficult. These results illustrate the mistakes that can occur with improper machine setup and an inexperienced operator.

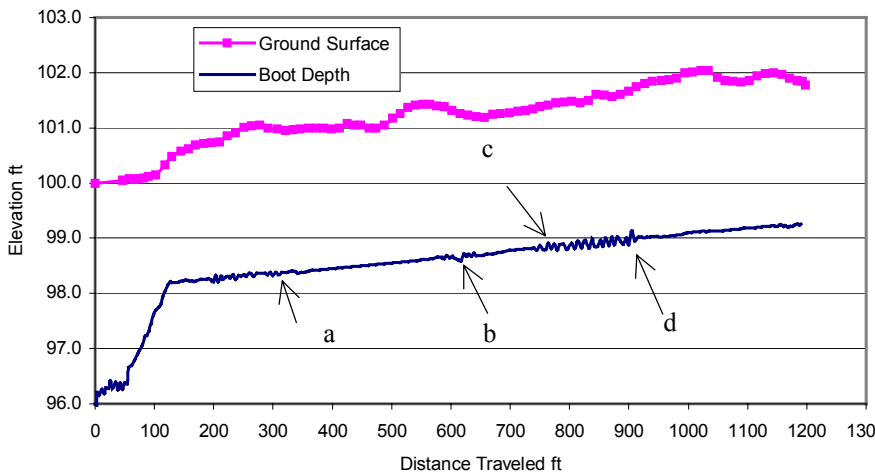
Figure 4. High wind conditions.

Figure 4. This boot depth graph shows the effect of wind on the laser transmitter, which was set up approximately 500' from the receiver. Before letter "a" the graph shows a little static, but the noise smoothed out from "a" to "c". At letter "b" the transmitter actually shut down and the operator changed the wind sensitivity level to 0. At "d" the transmitter was tied down to an auger, then this system operated within the detection limits of the GeoStar System, as shown on the graph after letter "d". Figure 5 and 6 show one way to firmly mount the tripod to the ground, thus helping to reducing the potential for error. The maximum deviation in grade between points "c" and "d" is 0.25', which is greater than $\frac{1}{2}$ the inside diameter of the pipe being installed.

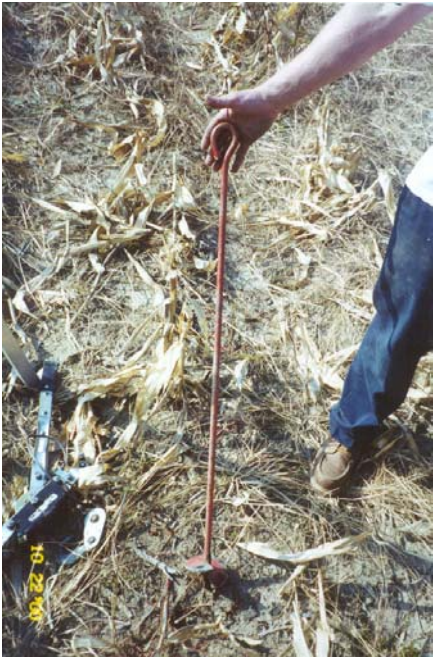
(Figure 5) Auger

Figure 5. This type of auger can be purchased from almost any local hardware store. The auger needs to be driven in the ground to approximately two feet. The benefits are tremendous when using a taller tripod.

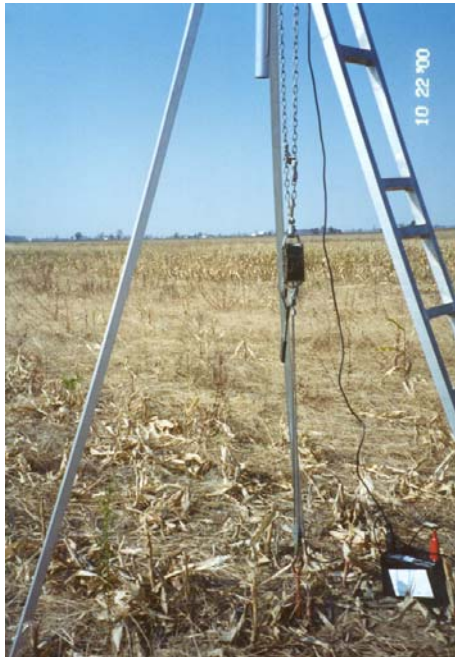
(Figure 6) Tripod setup

Figure 6 illustrates a fully setup tripod with a come-along installed to tighten the tripod firmly with the ground anchor.

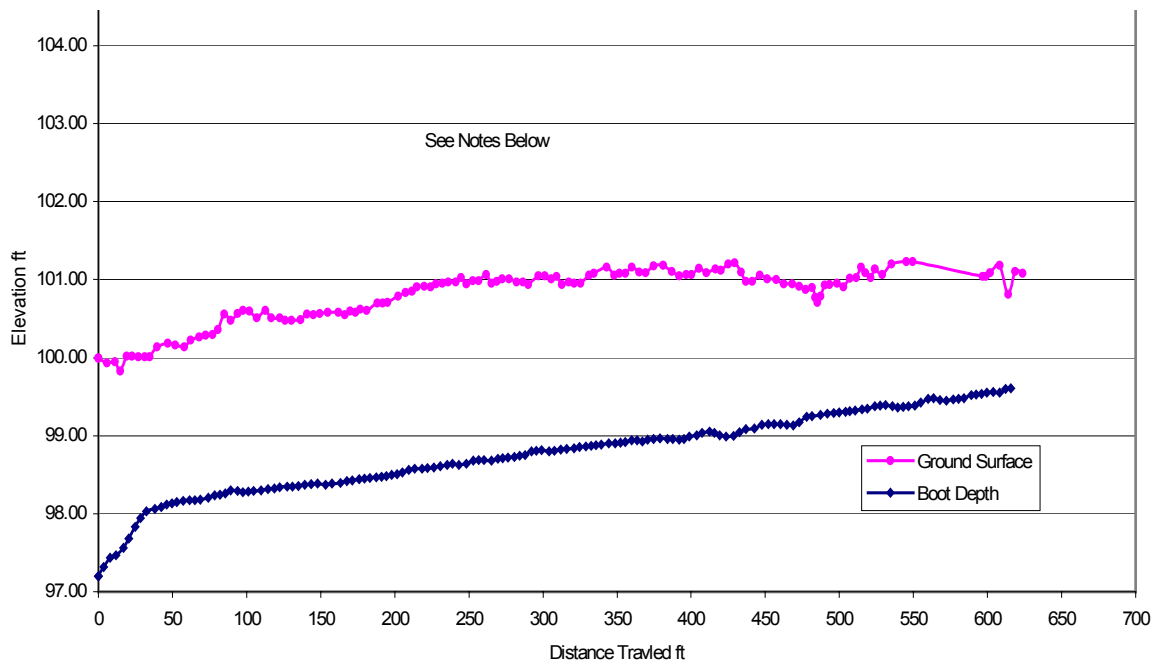
Split Pine Farms Plow Evaluation

- ❖ Soils were Mahoning silt loam 0-2 % slope. Soil water content was 17–20%.
- ❖ Plow was pulled by a John Deere 8410 (loaded with approximately 1300 lbs on front) at a speed of 1.1 mile per hour, 95 feet per minute (100 feet timed during run).
- ❖ Installation grade was established at 0.004 ft/ft, and laser grade control was performed using a Spectra Physics system. The initial depth was estimated to be 2.8 feet.
- ❖ At 429 feet the system went down 0.06 feet at the edge of a wet spot.

- ❖ GeoStar system (Spectra-Precision) mast was mounted over the rear of the tubing boot to detect the relative elevation of the pipe as it exited the tubing boot, therefore the installed pipe depth is apparent.
- ❖ The accuracy of the GeoStar System was approximately 0.015 ft.

The Split Pines Farms' Pine Swartly Plow from the state of New York was by far the smallest of the plows at this field day. The plow had a V-bottom that keeps with the ASTM 449-97 specification. This plow had a maximum depth of only 4.5 feet and this model sells only with a 4-inch boot. The plow has a three-point linkage that is not in float, and therefore has some manual control. This model had no pipe feeder. We have observed the Split Pines plow with the GeoStar system three times at one site, while pulled with a John Deere 8410.

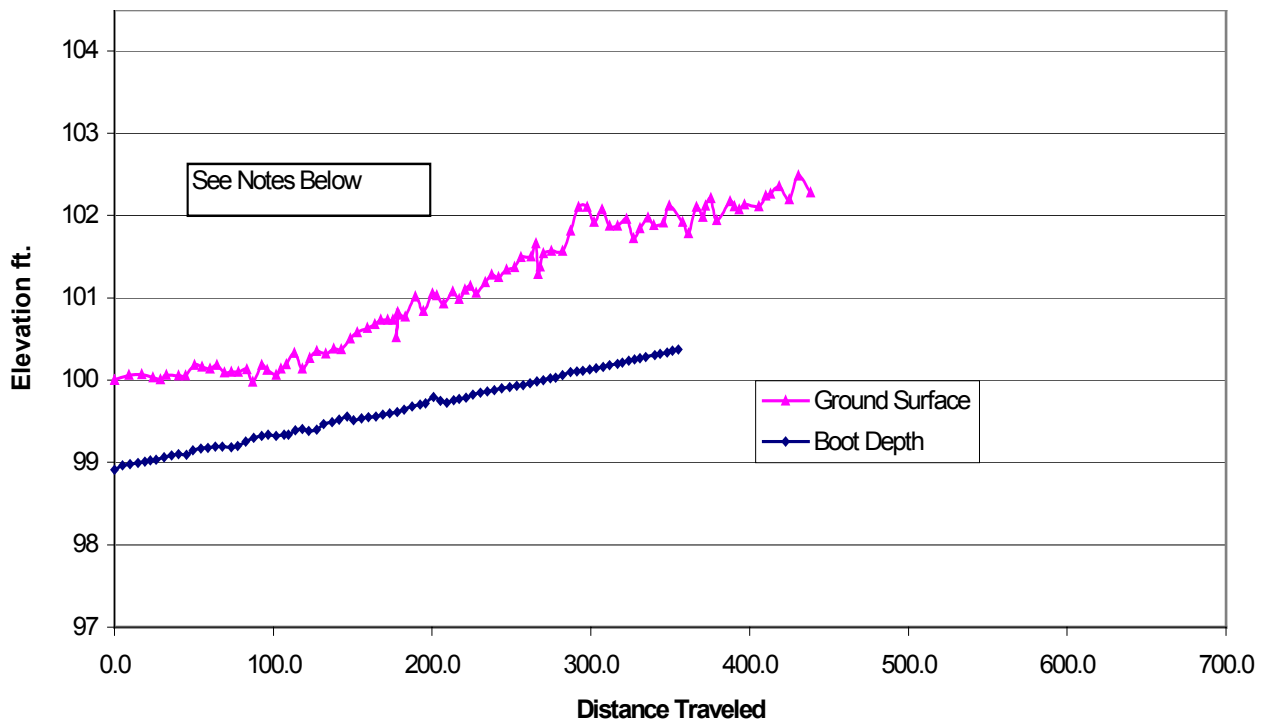
Winthrop Welding Works Yieldmaster Plow Evaluation

- ❖ Soils were Mahoning silt loam 0-2 % slope. Soil water content 17 – 20%.
- ❖ Plow was pulled by a Steiger Panther KP-1325 at a speed of 0.8 mile per hour, 70 feet per minute (100 feet timed during run).
- ❖ Installation grade was established at 0.004 ft/ft, and laser grade control was performed using a Laser Alignment system. The initial depth was estimated to be 0.8 feet.
- ❖ GeoStar system (Spectra-Precision) mast was mounted over the rear of the tubing boot to detect the relative elevation of the pipe as it exited the tubing boot, therefore the installed pipe depth is apparent.
- ❖ The accuracy of the GeoStar System was approximately 0.015 ft.

This plow uses a double linkage that helps distribute the draft of the plow to a virtual hitch point in front of the pulling implement. This plow had a round bottom with a straight cutting point, and had options of installing 4, 5, 6, 8 and 10-inch drainage pipe up to 5.0 feet deep. During the Lorain County Field Day this plow was mounted on a trailer thus losing the ability to transfer weight to the towing vehicle. During the field day this plow did not have a hydraulic or electric mast making it impossible for this plow to operate through the hill that was present during the field day. This model had no pipe feeder. We have observed the Winthrop plow with the GeoStar system twice at one site, once pulled with a Case 9370 and once with a Steiger Panther.

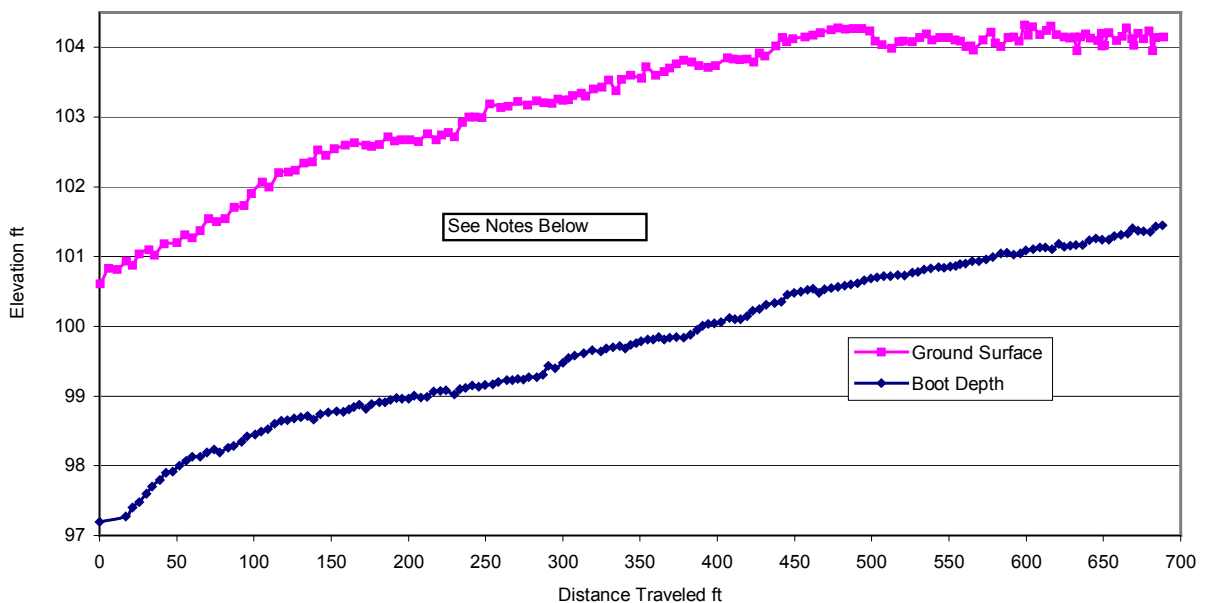
Liebrecht Ditcher Plow Evaluation

- ❖ Soils were Mahoning silt loam 0-2 % slope. Soil water content 17–20%.
- ❖ Plow was pulled by a Case 9370 (loaded with approximately 3000 lbs on the rear) at a speed of 1.6 mile per hour, 140 feet per minute (100 feet timed during run).
- ❖ Installation grade was established at 0.004 ft/ft, and laser grade control was performed using a Laser Alignment system. The initial depth was estimated to be 2.8 feet.
- ❖ At 245 feet something in the soil was hit causing the pipe to go down 0.02ft. At 280 and 380 feet the operator manually broke grade.
- ❖ GeoStar system (Spectra-Precision) mast was mounted over the rear of the tubing boot to detect the relative elevation of the pipe as it exited the tubing boot, therefore the installed pipe depth is apparent.
- ❖ The accuracy of the GeoStar System was approximately 0.015 ft.

The Liebrecht Ditcher is a pull-type model that has a pipe feeder, and a tilt adjustment if it encounters ground conditions where one side of the plow is higher or lower than the other. The hydraulically controlled mast has numbers are every tenth of a foot to help the operator break grade. The mast extends well above the tractor cab to reduce the possibility of the cab interfering with the laser reception. The Ditcher plow has a Boot Pressure Regulator, which keeps 500 pounds pressure on the transport wheels in order to help the plow from sinking in

soft bottom conditions. This plow has options of installing 4, 5, 6, and 8-inch drainage pipe up to 5.5 feet deep. Instead of the ASTM 449–97 specification, this plow has a straight fracture point and a flat bottom. The bottom of the boot has a small nub which is pressed into the soil at the bottom of the plow slot to form a support for the pipe. We have observed the Liebrecht plow with the GeoStar system 12 times, at five different sites pulled with a Steiger 210 Wildcat, John Deere 8410, Case 9370, Fent 926, and Case STX 375 Quadtrax, respectively.
